Operator Experience with Non-Gas Path Power Turbine  
Disc Corrosion as an Emergent Equipment Integrity Threat

Barry Ruggiero, P.Eng. / TransCanada

Presented at the 19th Symposium on Industrial Application of Gas Turbines (IAGT)  
Banff, Alberta, Canada - October 17-19, 2011

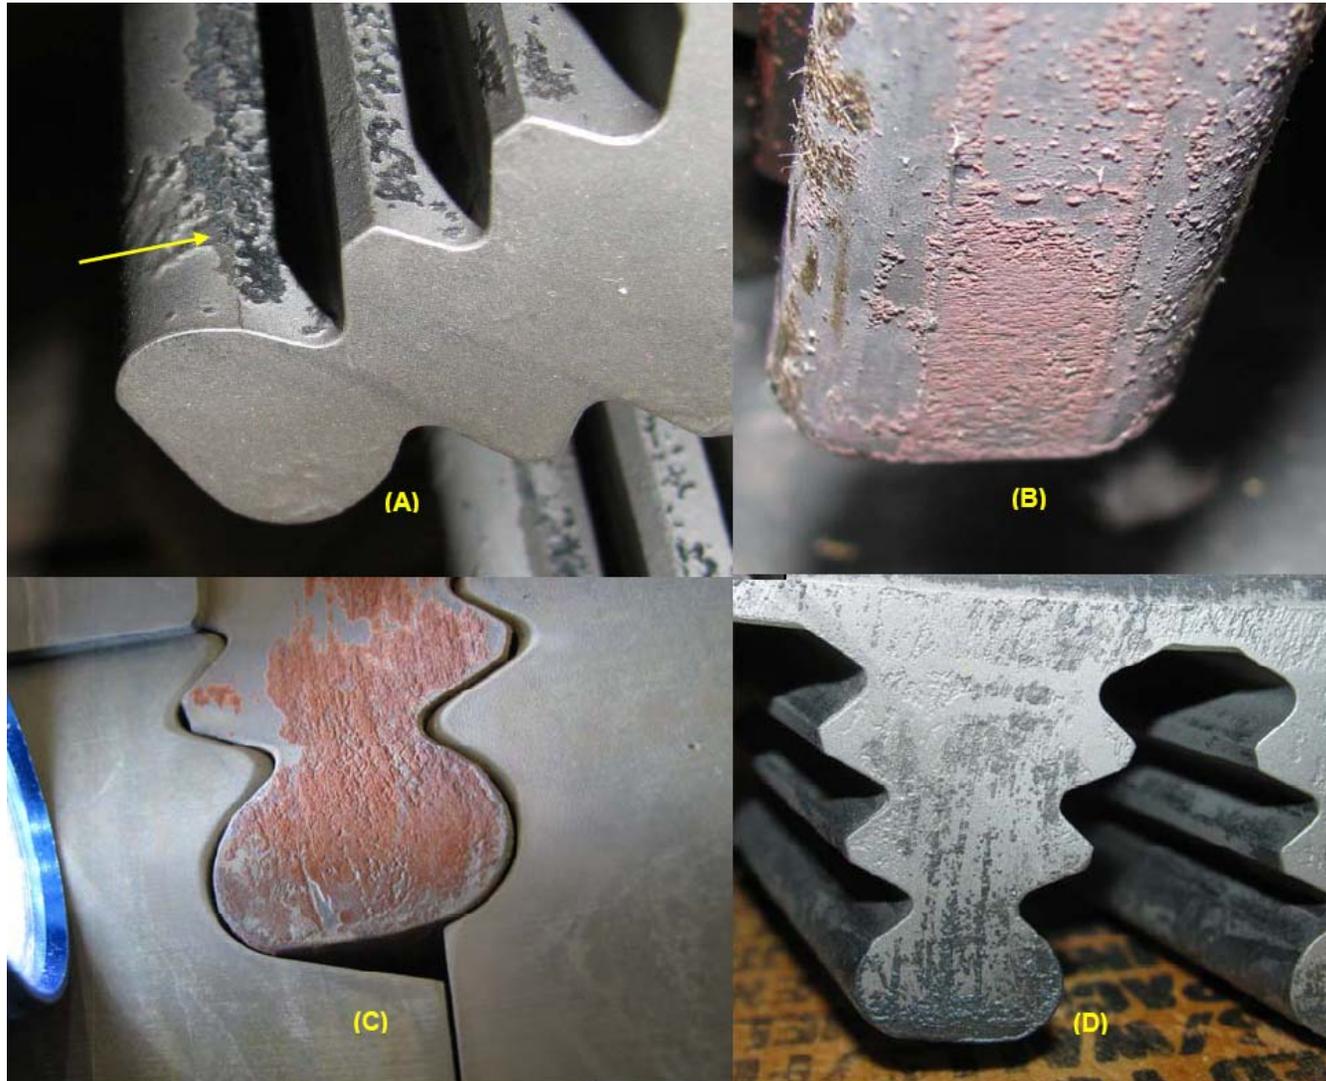
**Figure 1:** Example post conditions; A – Scale on serrations loaded surface (A-286); B – Scale on Post unloaded top face (I901); C – Post End face corrosion (I901); D – Identical disc (I901) after cleaning;

- Such scales have been investigated and have been found in some cases to show elevated molybdenum and sulphur, with products extending above the original surface some 27  $\mu\text{m}$  with a total reaction zone of 50  $\mu\text{m}$ . [1]

- In other cases, scales have featured Sodium, Magnesium, Calcium, Silicon, Cobalt, in addition to Sulphur and occasionally phosphorous. A hypothesis here involves foreign contaminants, from the environment and/or possibly remnant glass bead fines, play a role in forming a slag. It is suggested Cobalt may be a product of corrosion of the airfoil material that has transferred due to fretting action. Extreme cases found the thickness of the scale to be 114  $\mu\text{m}$ . [2] However, It has also been found that such scales can form on disc that have NOT been overhaul processed.

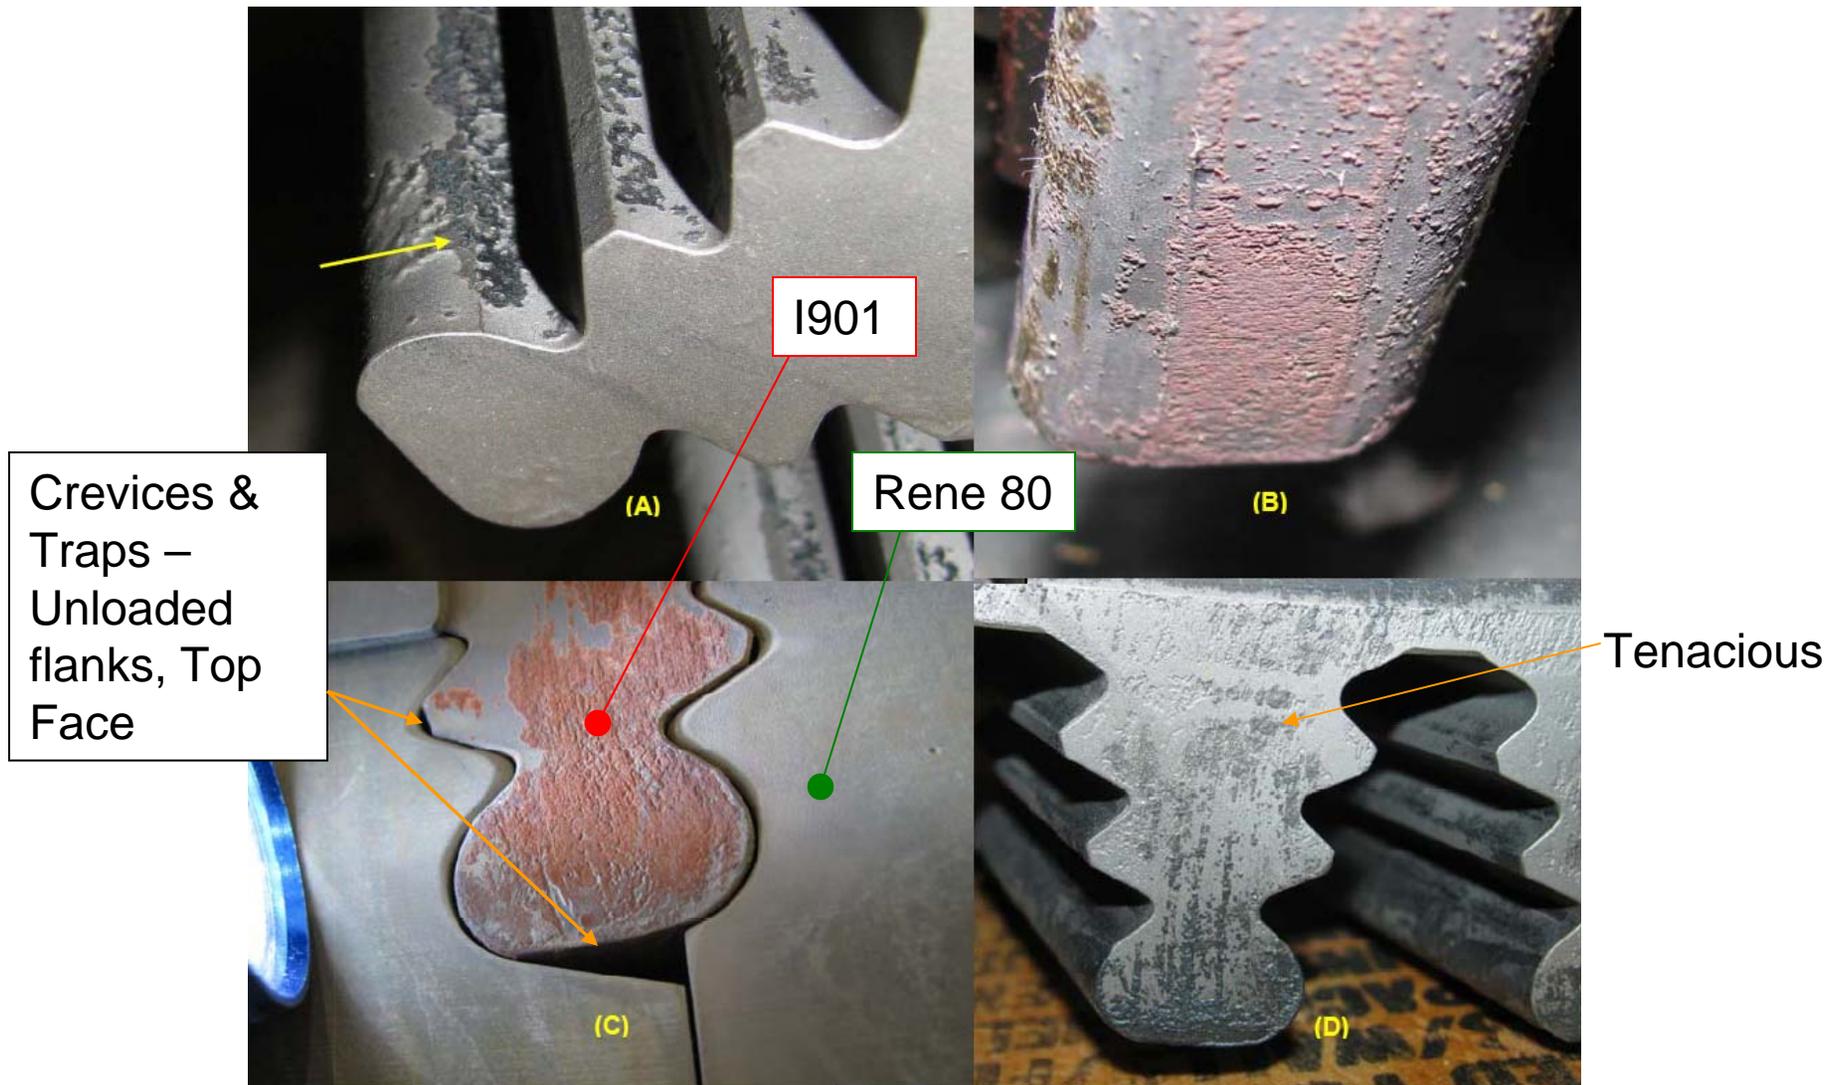
**Figure 1:** Example post conditions; A – Scale on serrations loaded surface (A-286); B – Scale on Post unloaded top face (I901); C – Post End face corrosion (I901); D – Identical disc (I901) after cleaning;

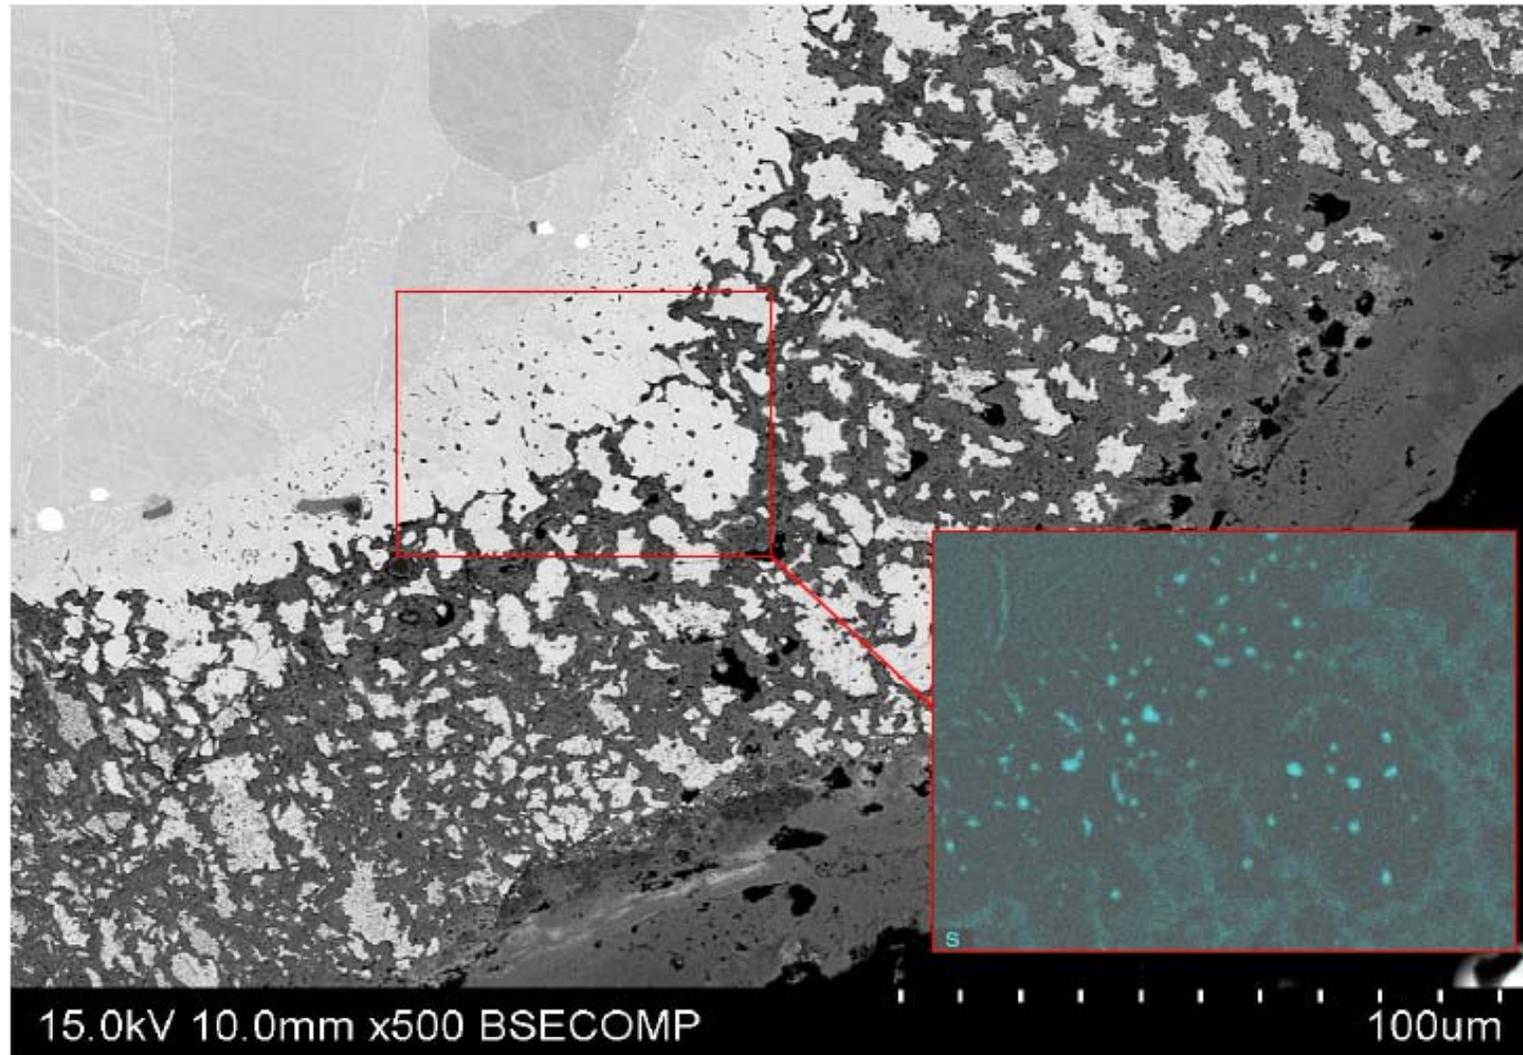
**Figure 2:** Sample corrosion on a post loaded serration (similar to Figure 1 (A)), featuring sulfide particles in a denuded zone under the scale. SEM Images courtesy G. White – RRRESI Materials Lab. [4]

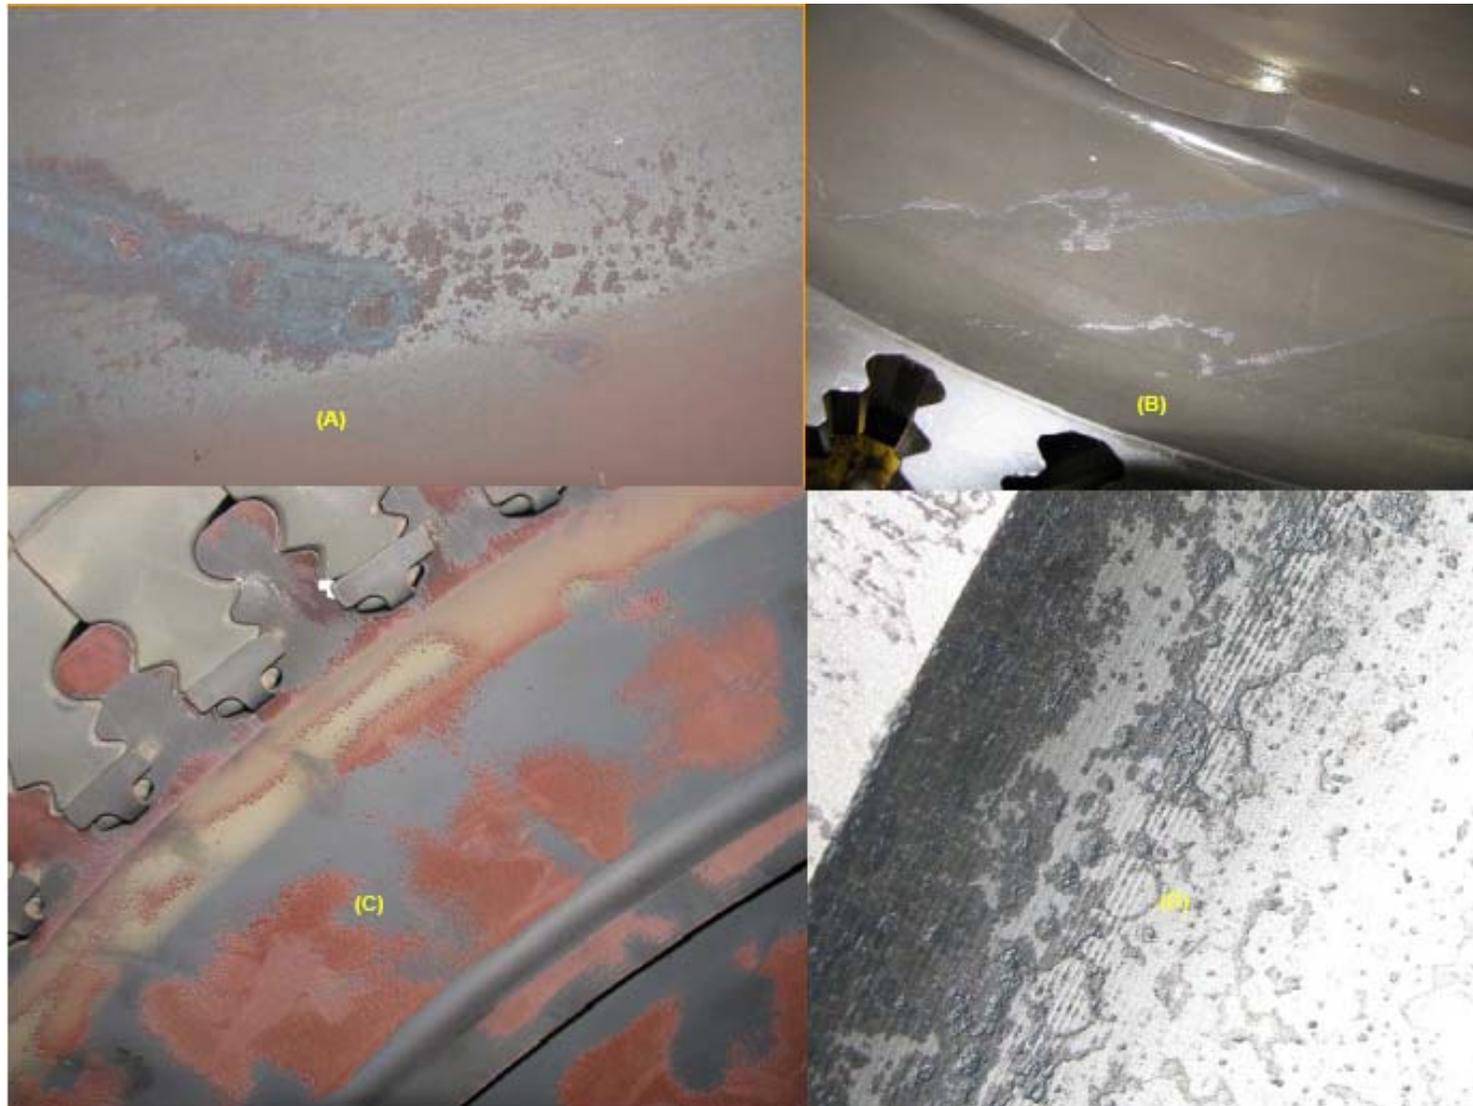
**Figure 3:** A – Corrosion and pitting near a drip like deposit on a web (A-286), B – localized scaled drip like deposit (I901), C – Patchy corrosion areas that extend above original surface (I901) D – Same disc as C after cleaning.

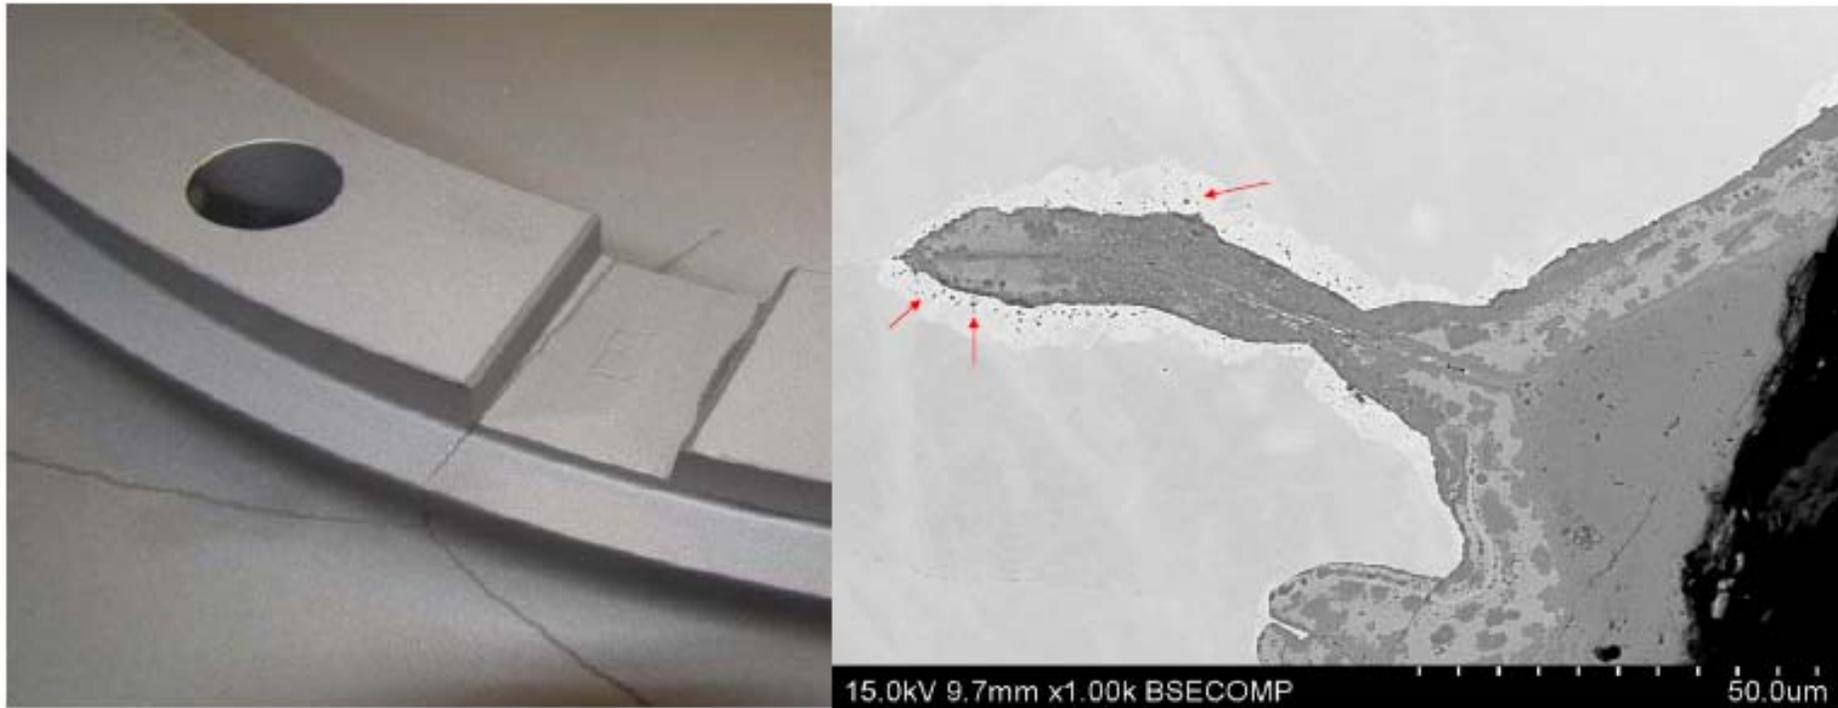
**Figure 4:** A crack at a torque transmission feature and a corrosion spike identified near the origin, featuring a chromium depleted area and sulphides (identified by red arrows) under thick scale. SEM Image courtesy G. White – RRESI Materials Lab. [12]

- Features as those shown near the hub / torque transmission features are obviously a significant concern. Whereas rim is an area where creep is a primary concern, the hub/flange areas are legitimate LCF areas. Adding corrosion spikes in such areas is problematic.
- Case in Point: All cracked discs were less than **550** cycles, whereas OEM have peaking power generation applications where such equipments have successfully been beyond 3500 cycles.
- These issues raise some intriguing questions:

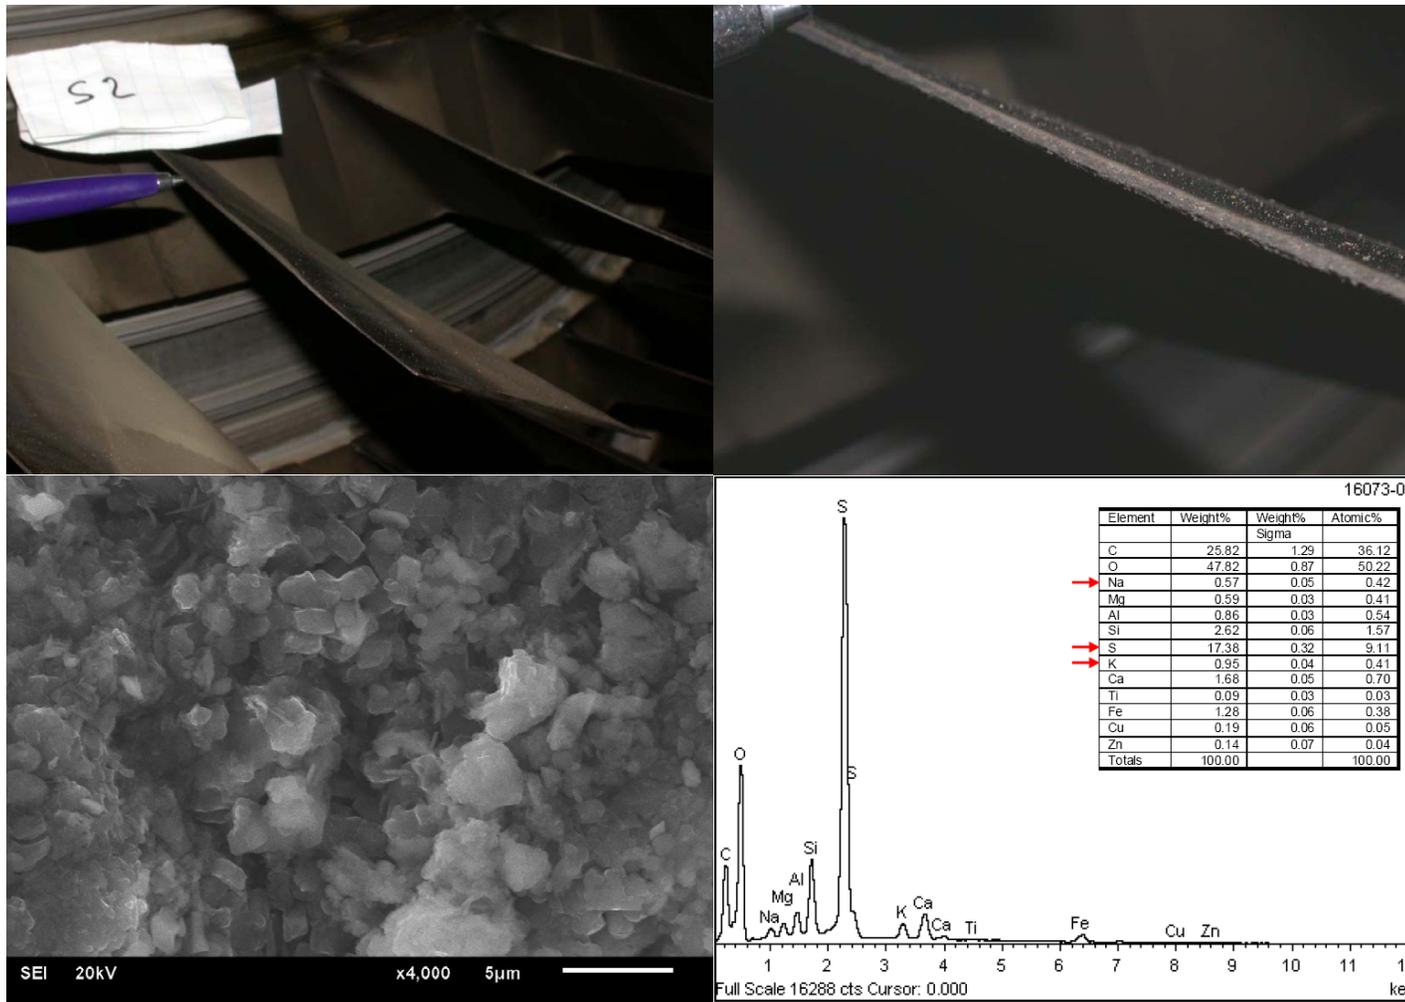
**Figure 13:** Richmond C/S: ESN 1750-116 IPC Stage Two blade deposits showing reactive species Na, S and K. GG was 3000 hours since last compressor wash. [45]

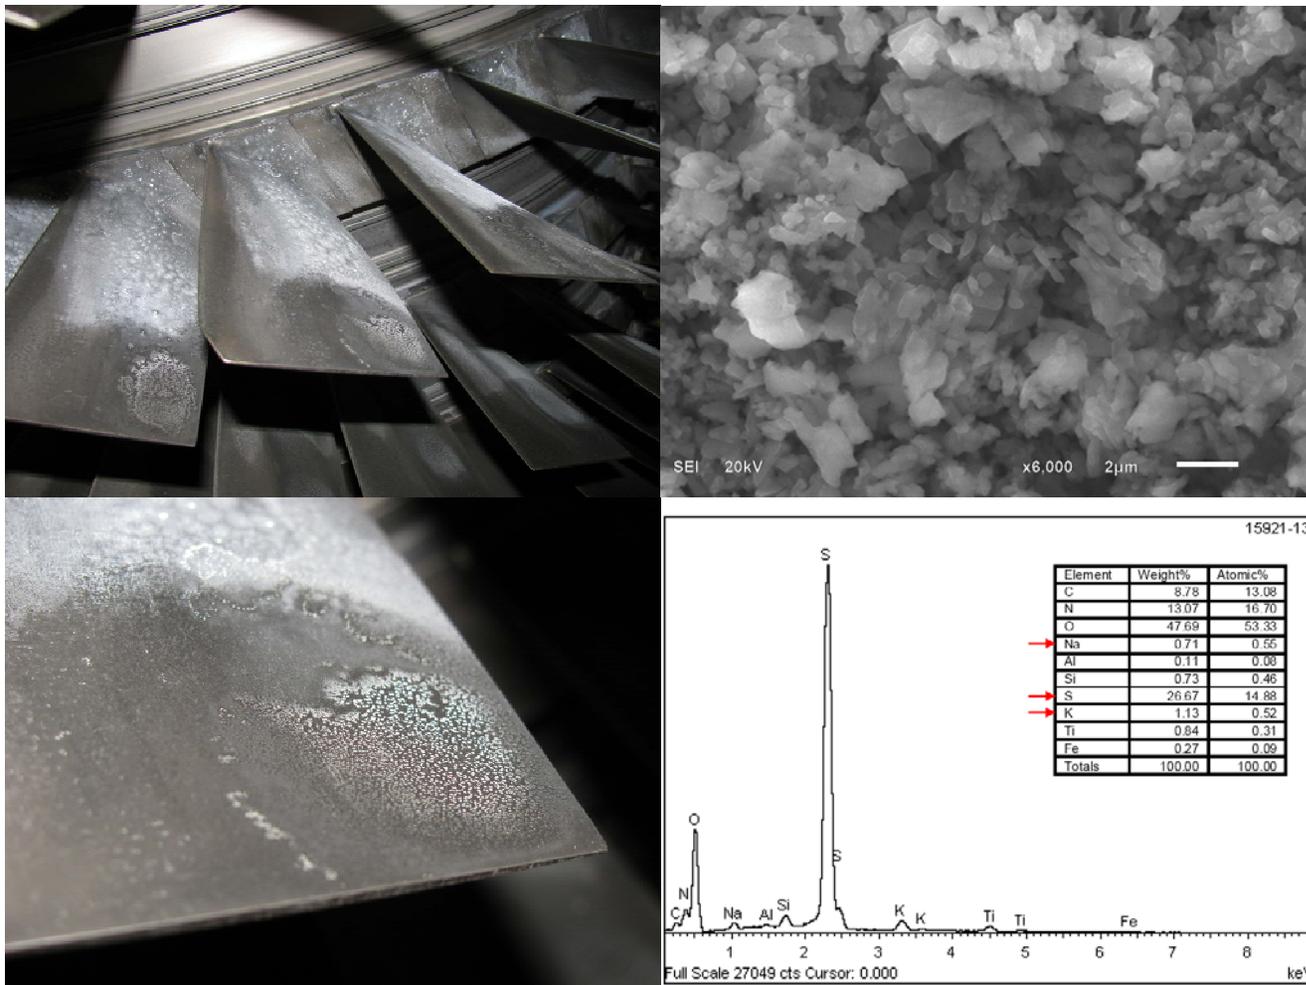
**Figure 14:** Deposits on IPC of ESN 1750-120 from Burstall (Sask) Compressor C/S. Engine was 530 hours since compressor wash. SEM Images from [46].

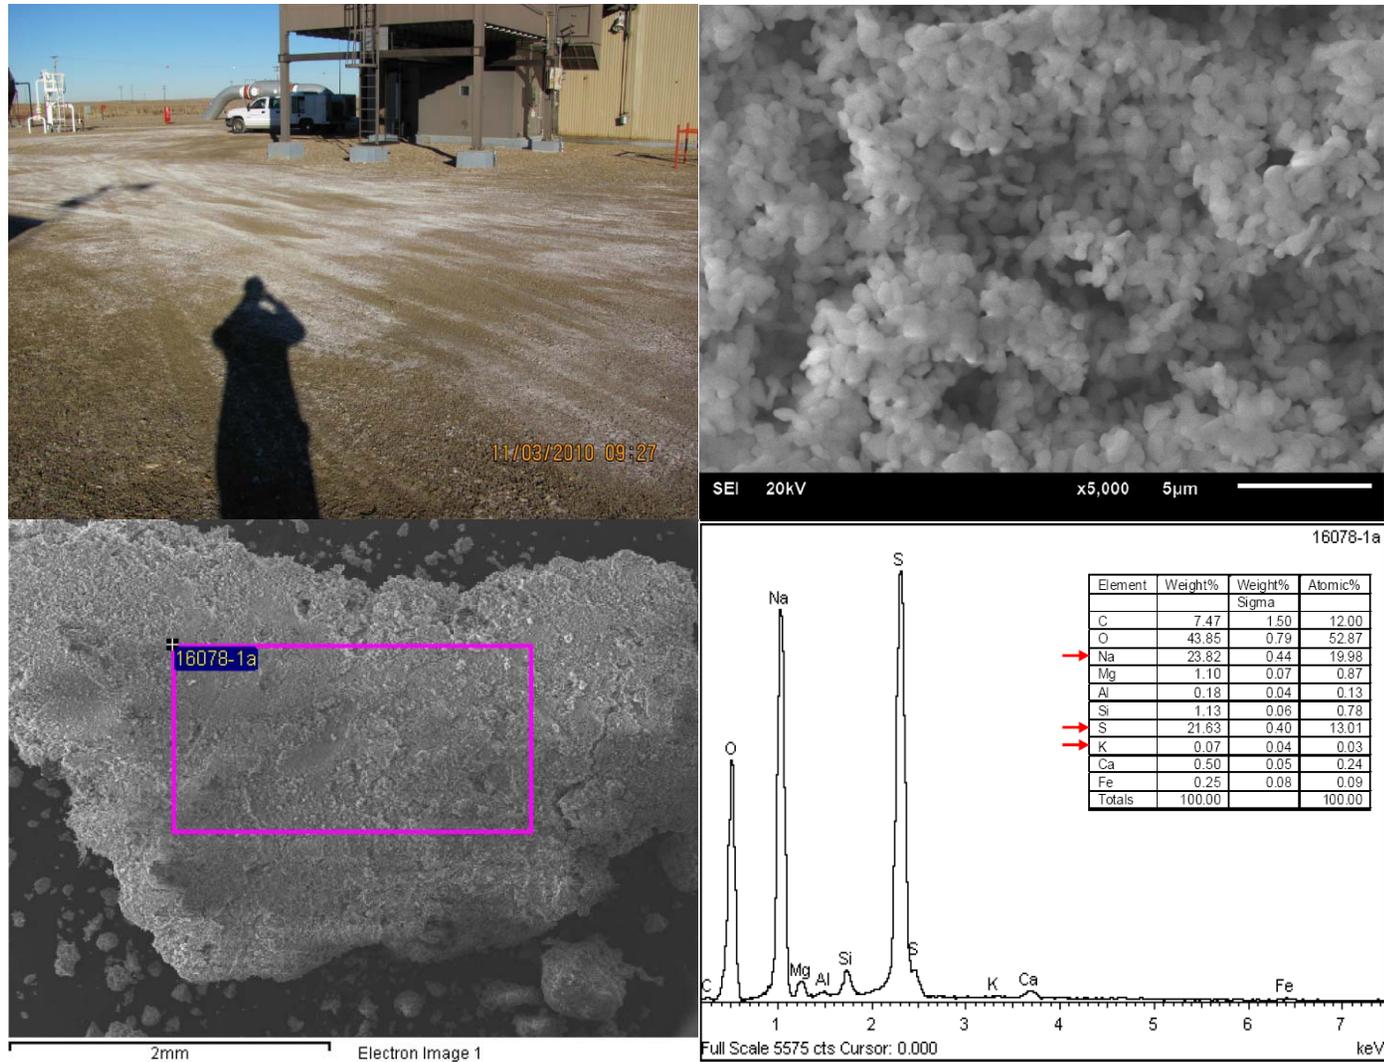
**Figure 15:** Jenner C/S (Alberta). Evaporite in yard and under plenum. SEM Images from [47].

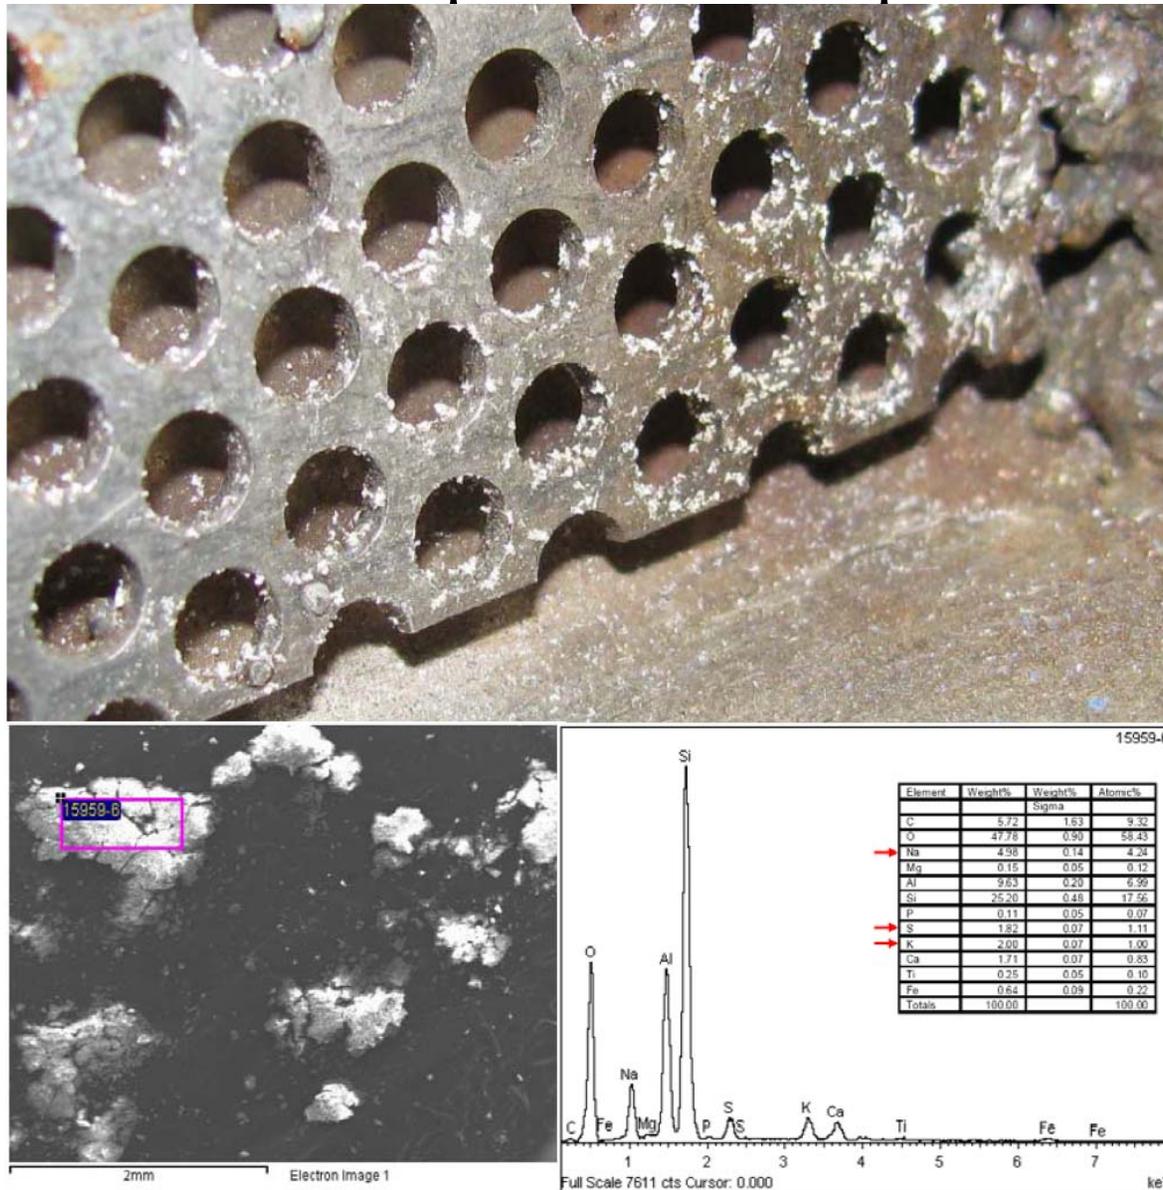
**Figure 18:** Latonell C/S (Alberta) White Crystalline deposits inside inlet plenum on acoustic lining, upstream of splitters. [49]

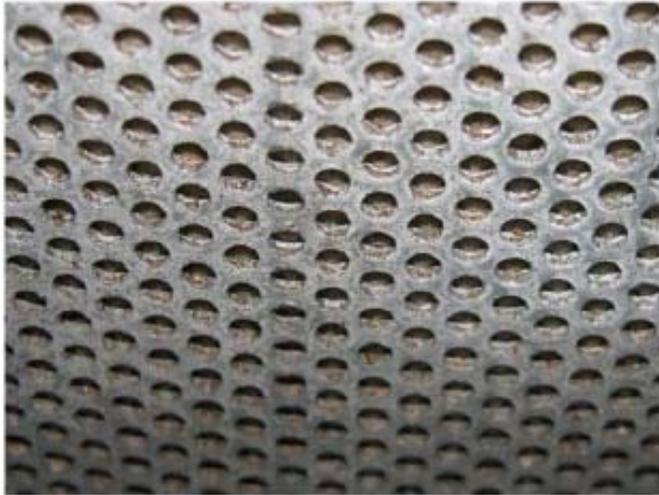
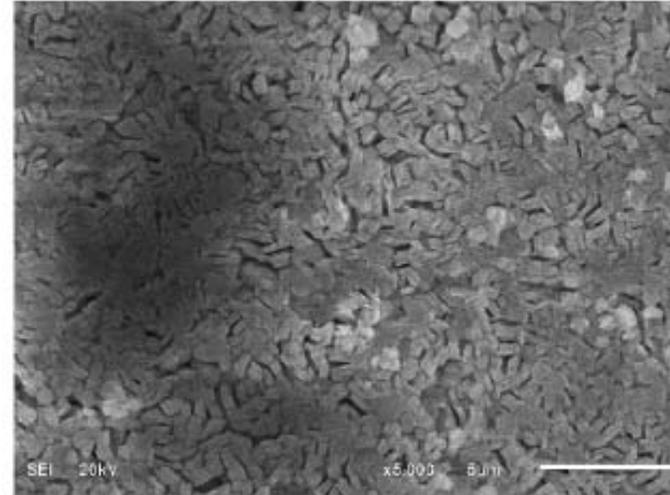
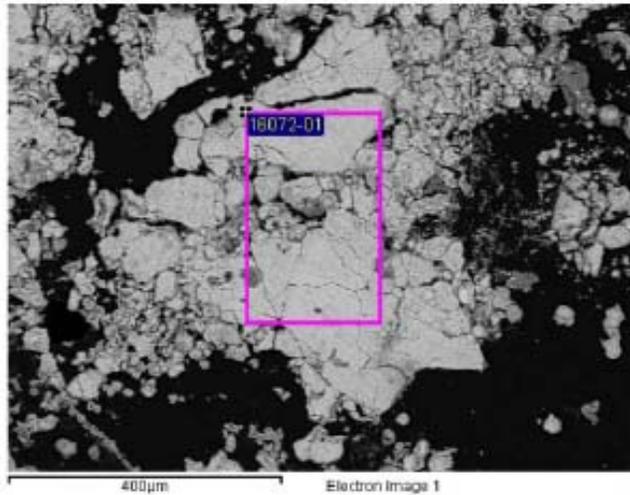
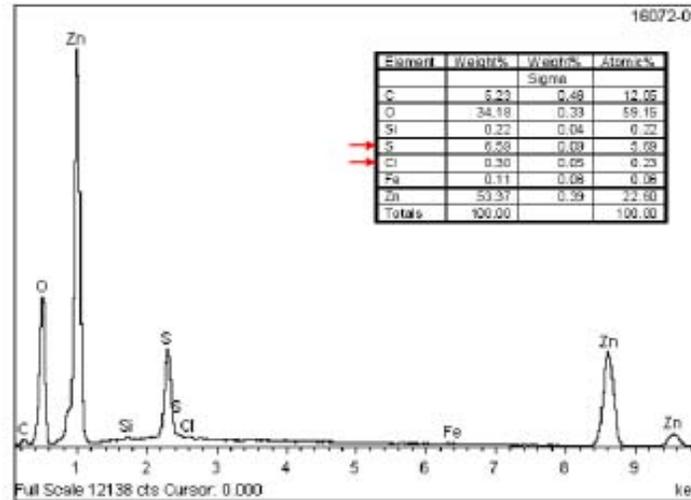
Vetchland C/S – Inlet Plenum deposits

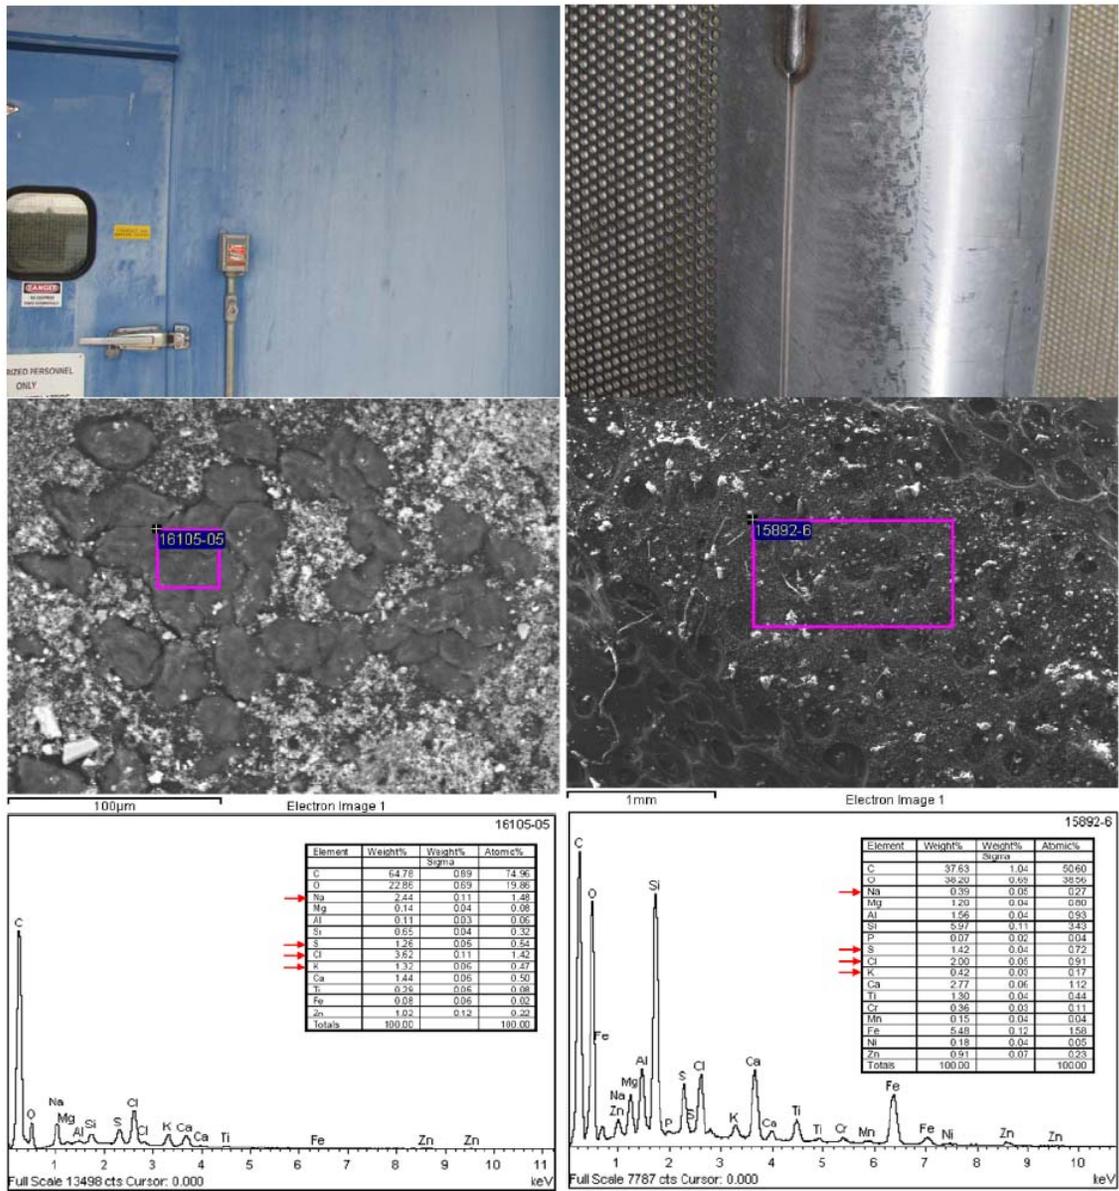
Vetchland C/S – Inlet Plenum deposits

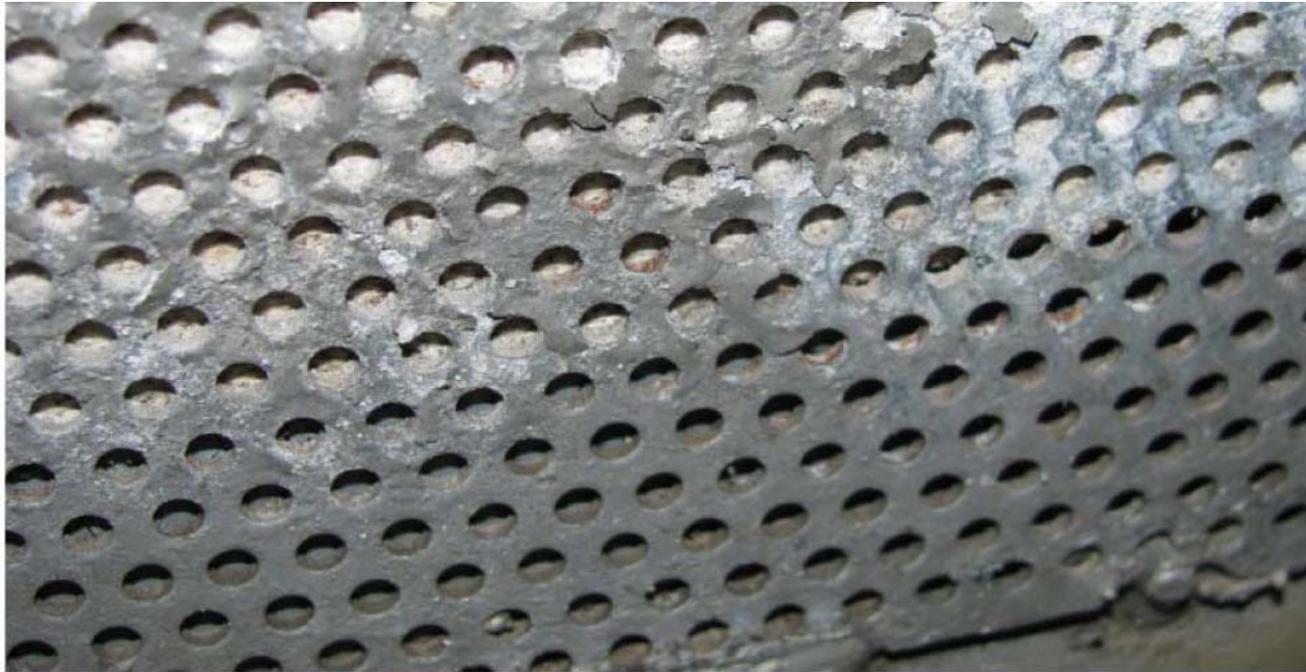
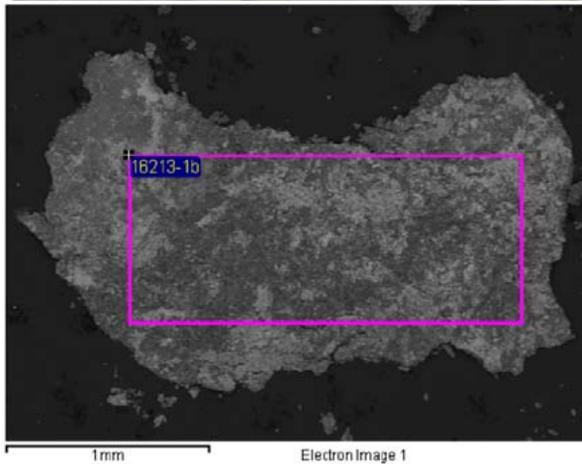
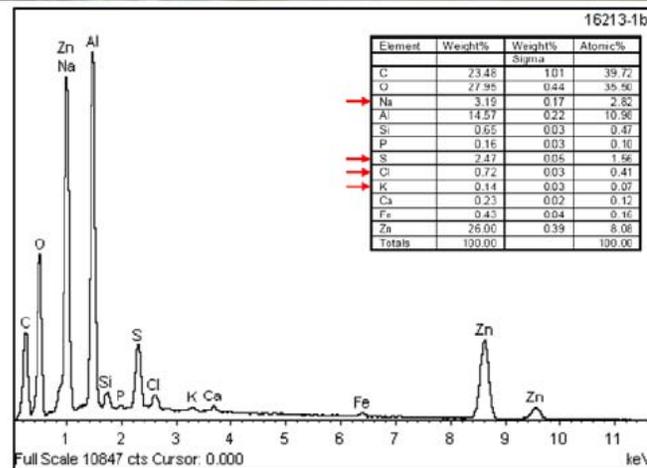
Station 17D – Inlet Plenum deposits

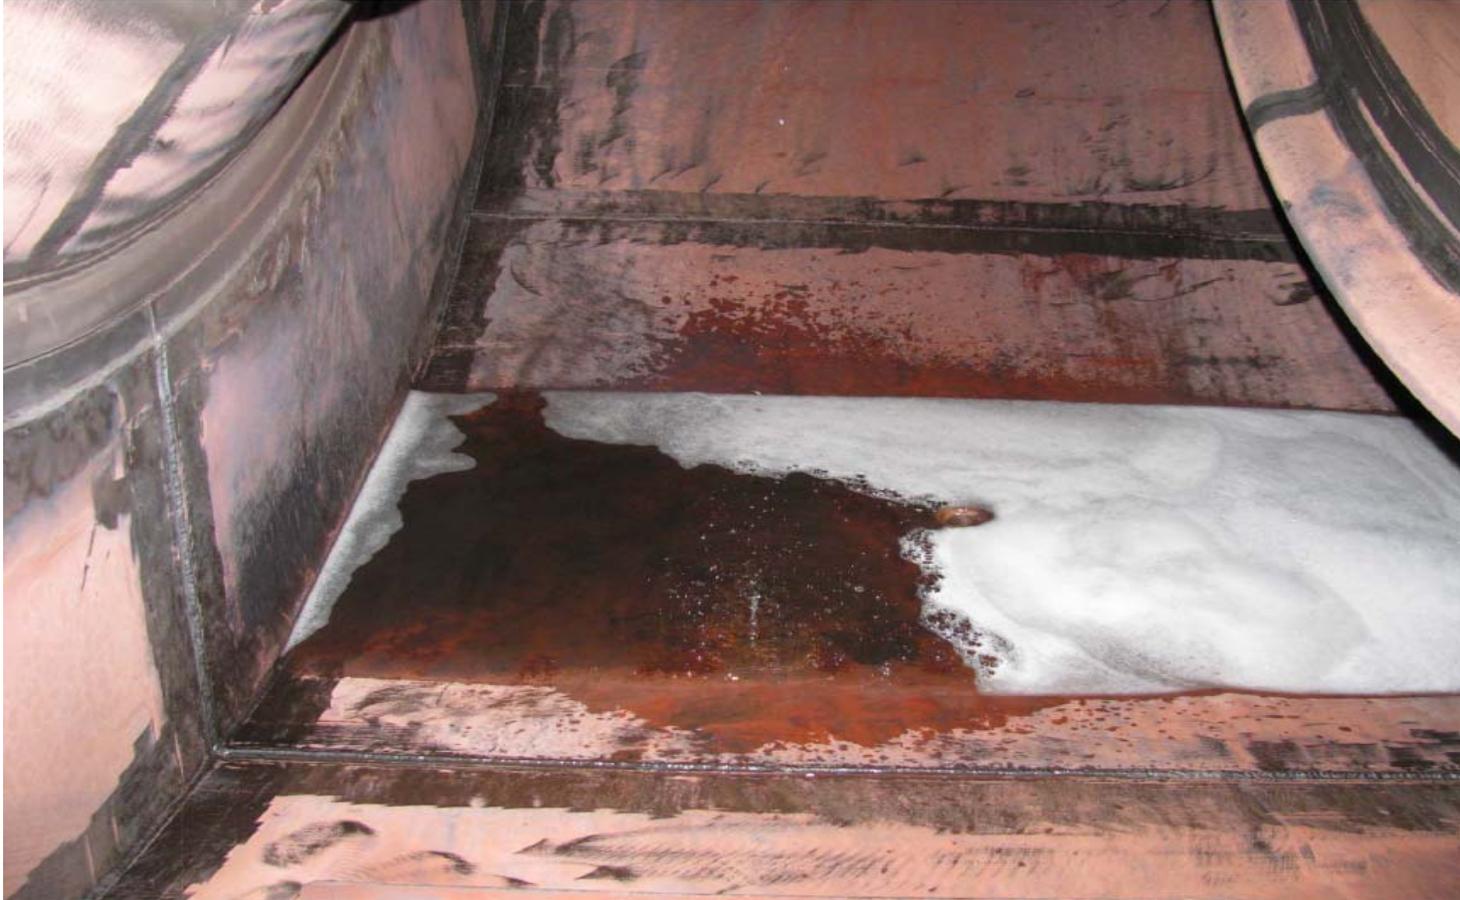
Fluid Did Make It to PT Exhaust (May be Process / Procedural Related)

- Water cleanliness / specification are paramount.
- Ensure no deviations from OEM procedures.
- Minimise likelihood and/or amount of carryover.
- In environments as described, fired washes not recommended.
- Consideration of post-compressor wash PT Rotor-Stator Cavity demineralised water rinse. (?)

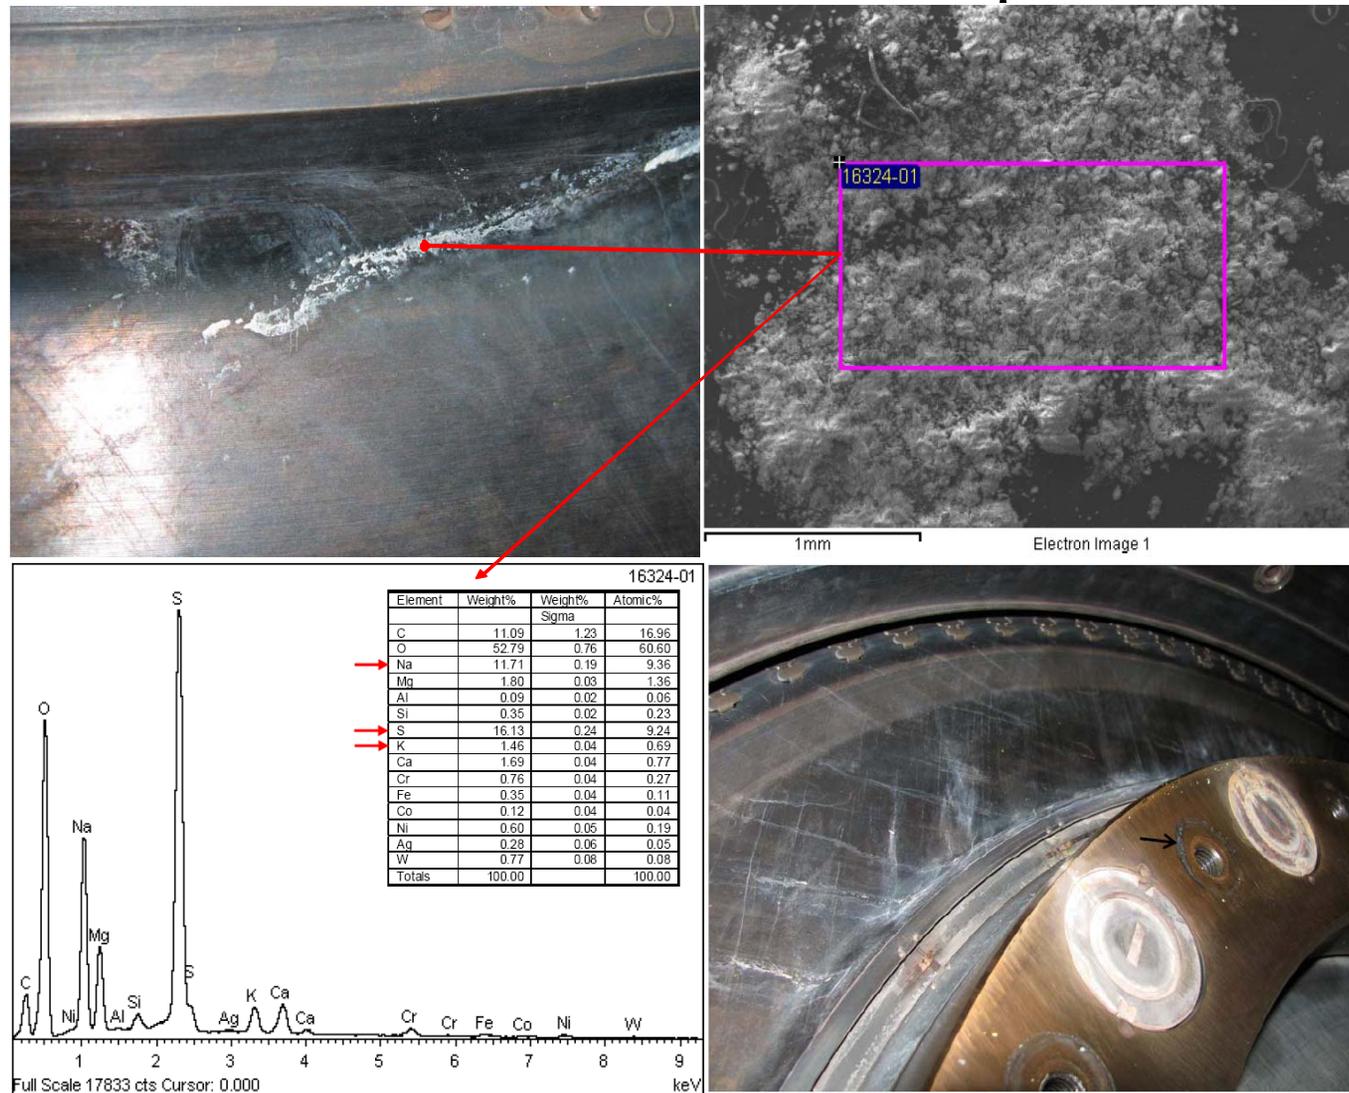
**Figure 22:** Vendor 2: prominent sodium and sulphur levels detected. Note the drip like pattern to the residue, which are suggestive that these were deposited when the unit PT was static as during soak wash. [52].

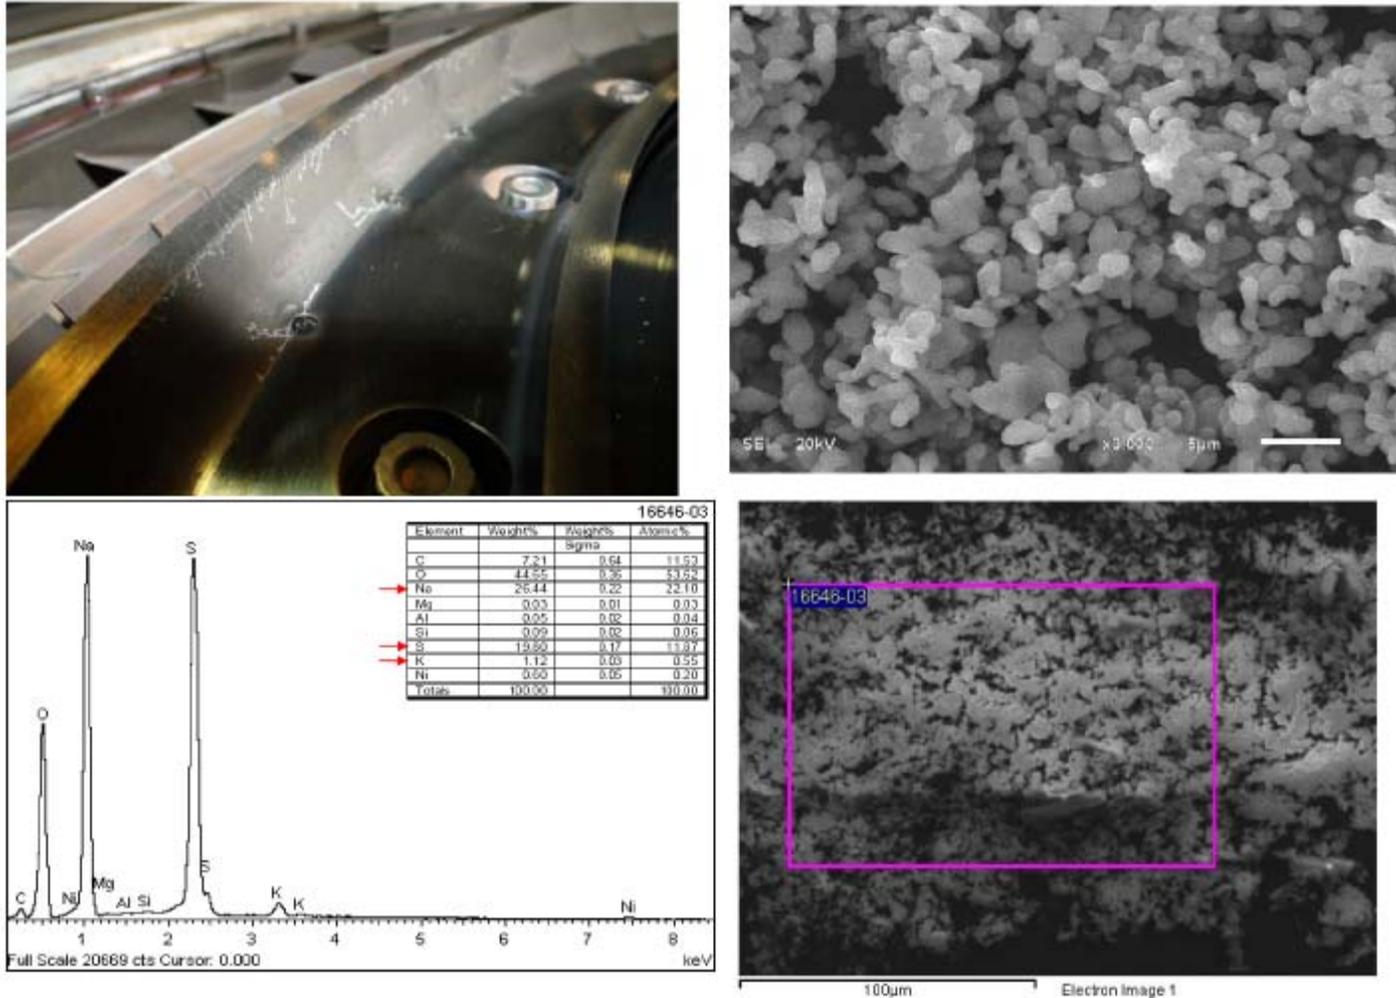
**Figure 23a:** Vendor 3. Evidence of crystalline deposits having worked through secondary air systems. [53]
