Operator Experience with Non-Gas Path Power Turbine  
Disc Corrosion as an Emergent Equipment Integrity Threat

Barry Ruggiero, P.Eng. / TransCanada

Presented at the 19th Symposium on Industrial Application of Gas Turbines (IAGT)  
Banff, Alberta, Canada - October 17-19, 2011

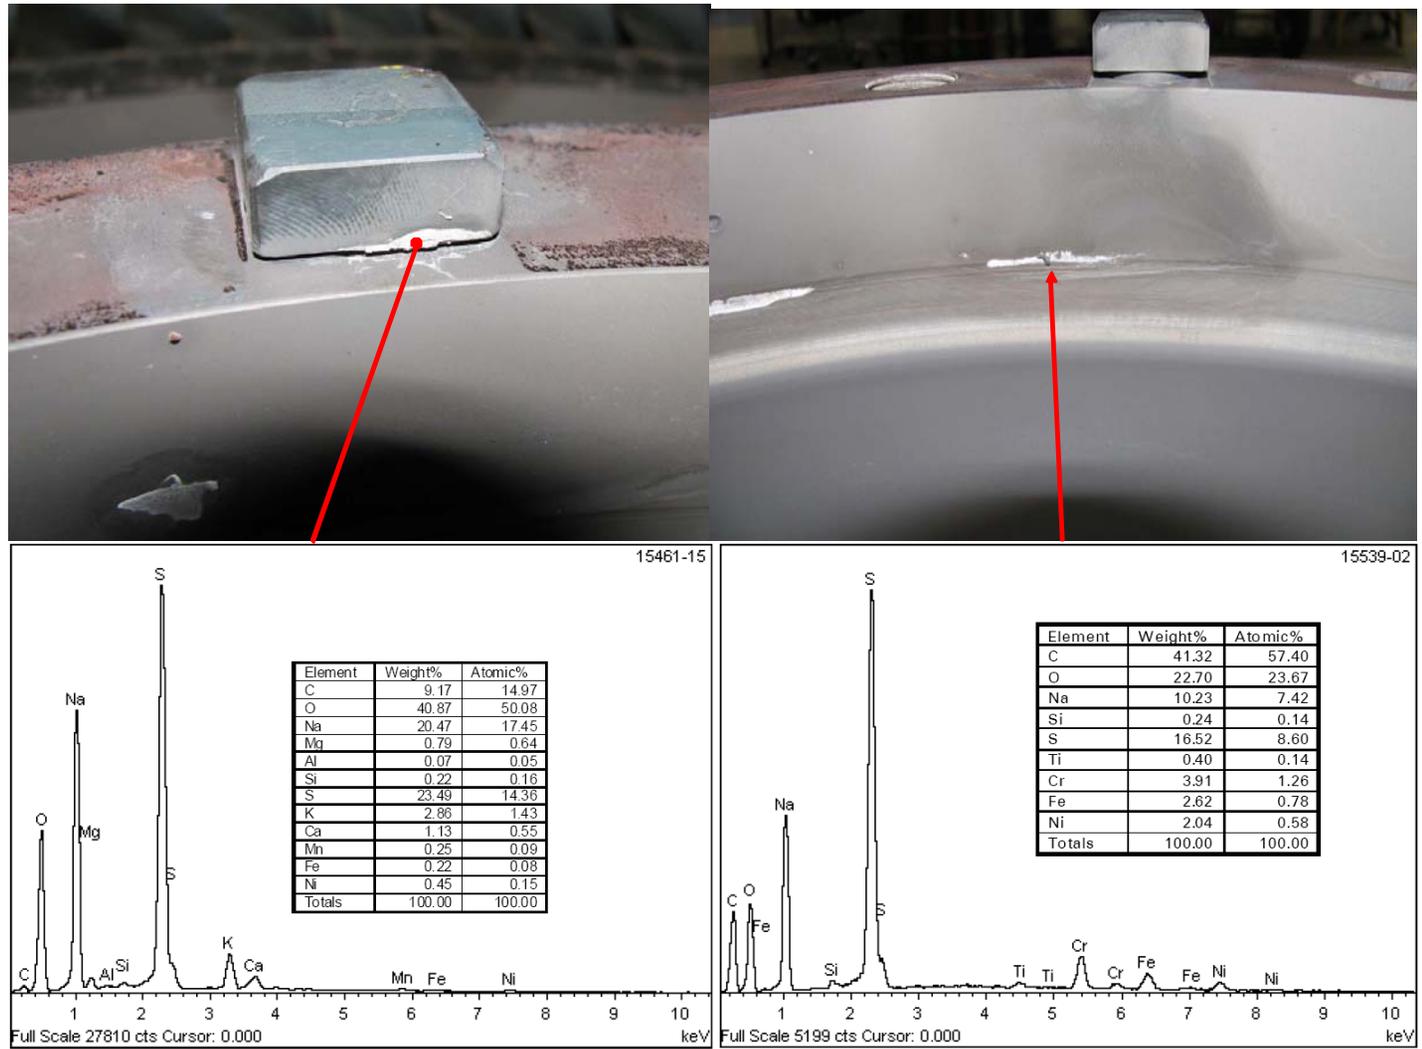
**Figure 24:** Deposits near torque transmission features on a power turbine from Red Deer River C/S (Alberta). [54]

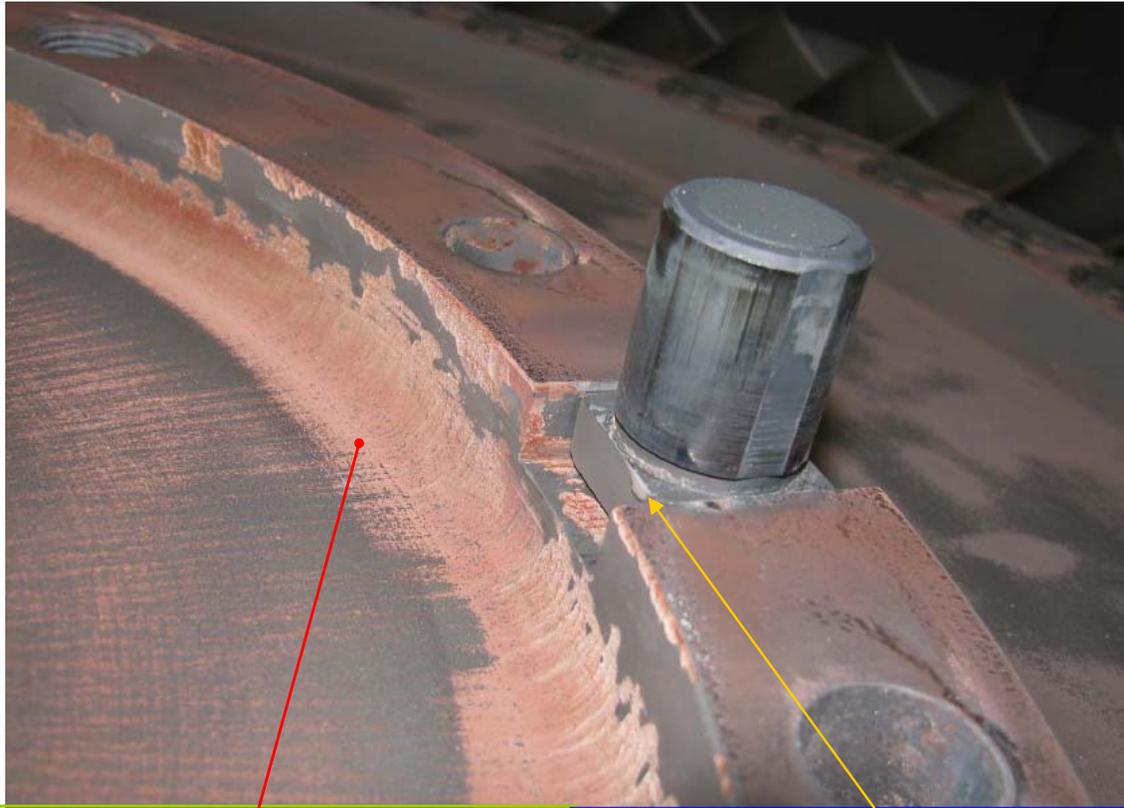
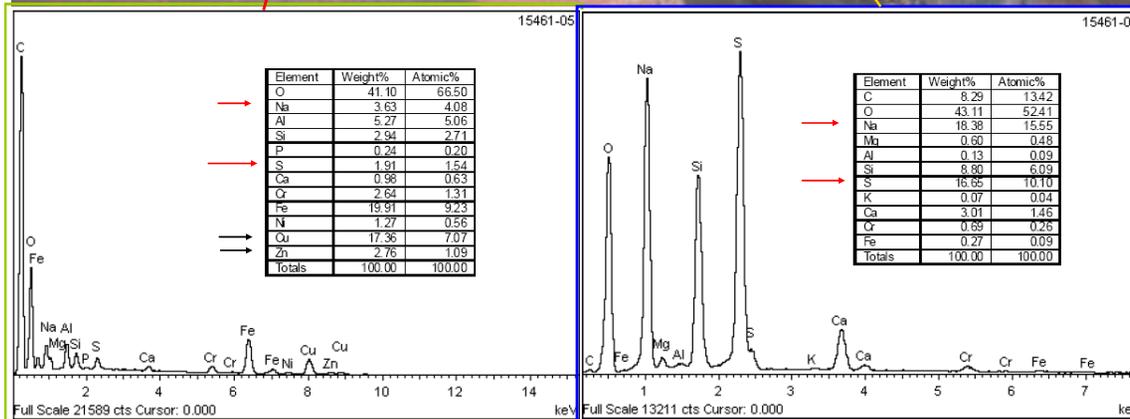
**Figure 26** – Deposits and analysis from a PT from Berland River C/S (Alberta). [56]

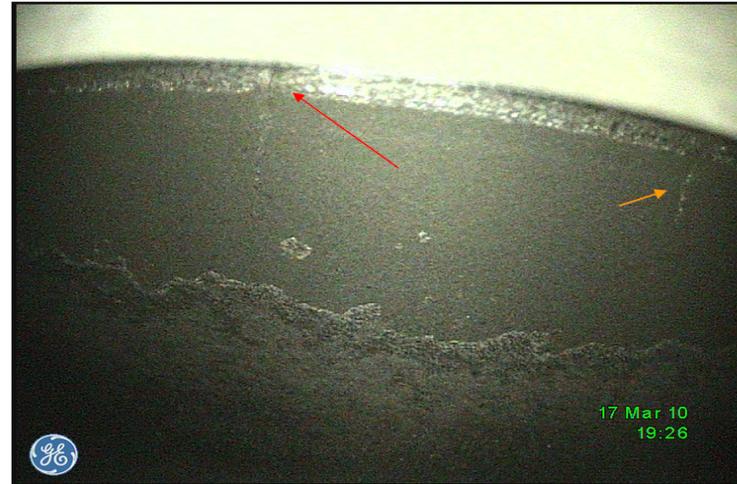
Case 1 - Boroscope Image – 1003170127.jpg; Was estimated at 3/16" at time.

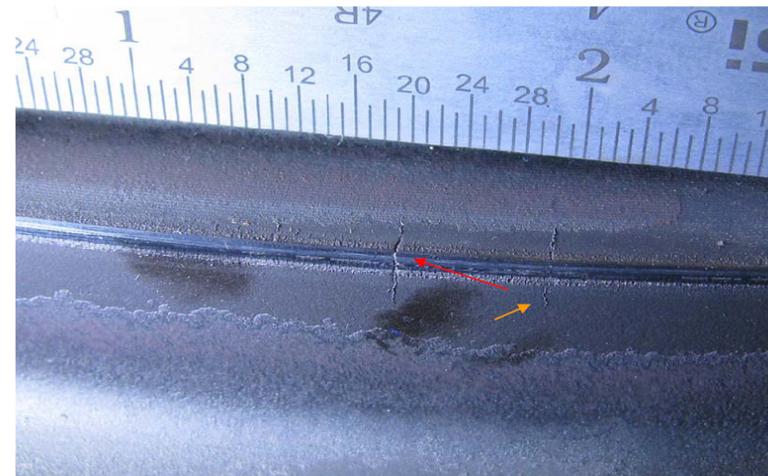
Case 1 - Indication near T-Pin Slot B – left hand later confirmed by UT.
